పోలవరం నిర్మాణంలో నాణ్యతా లోపాలు

కప్పిపుచ్చే ప్రయత్నాలు

02-03-2026

మీడియా సమావేశం, విజయవాడ

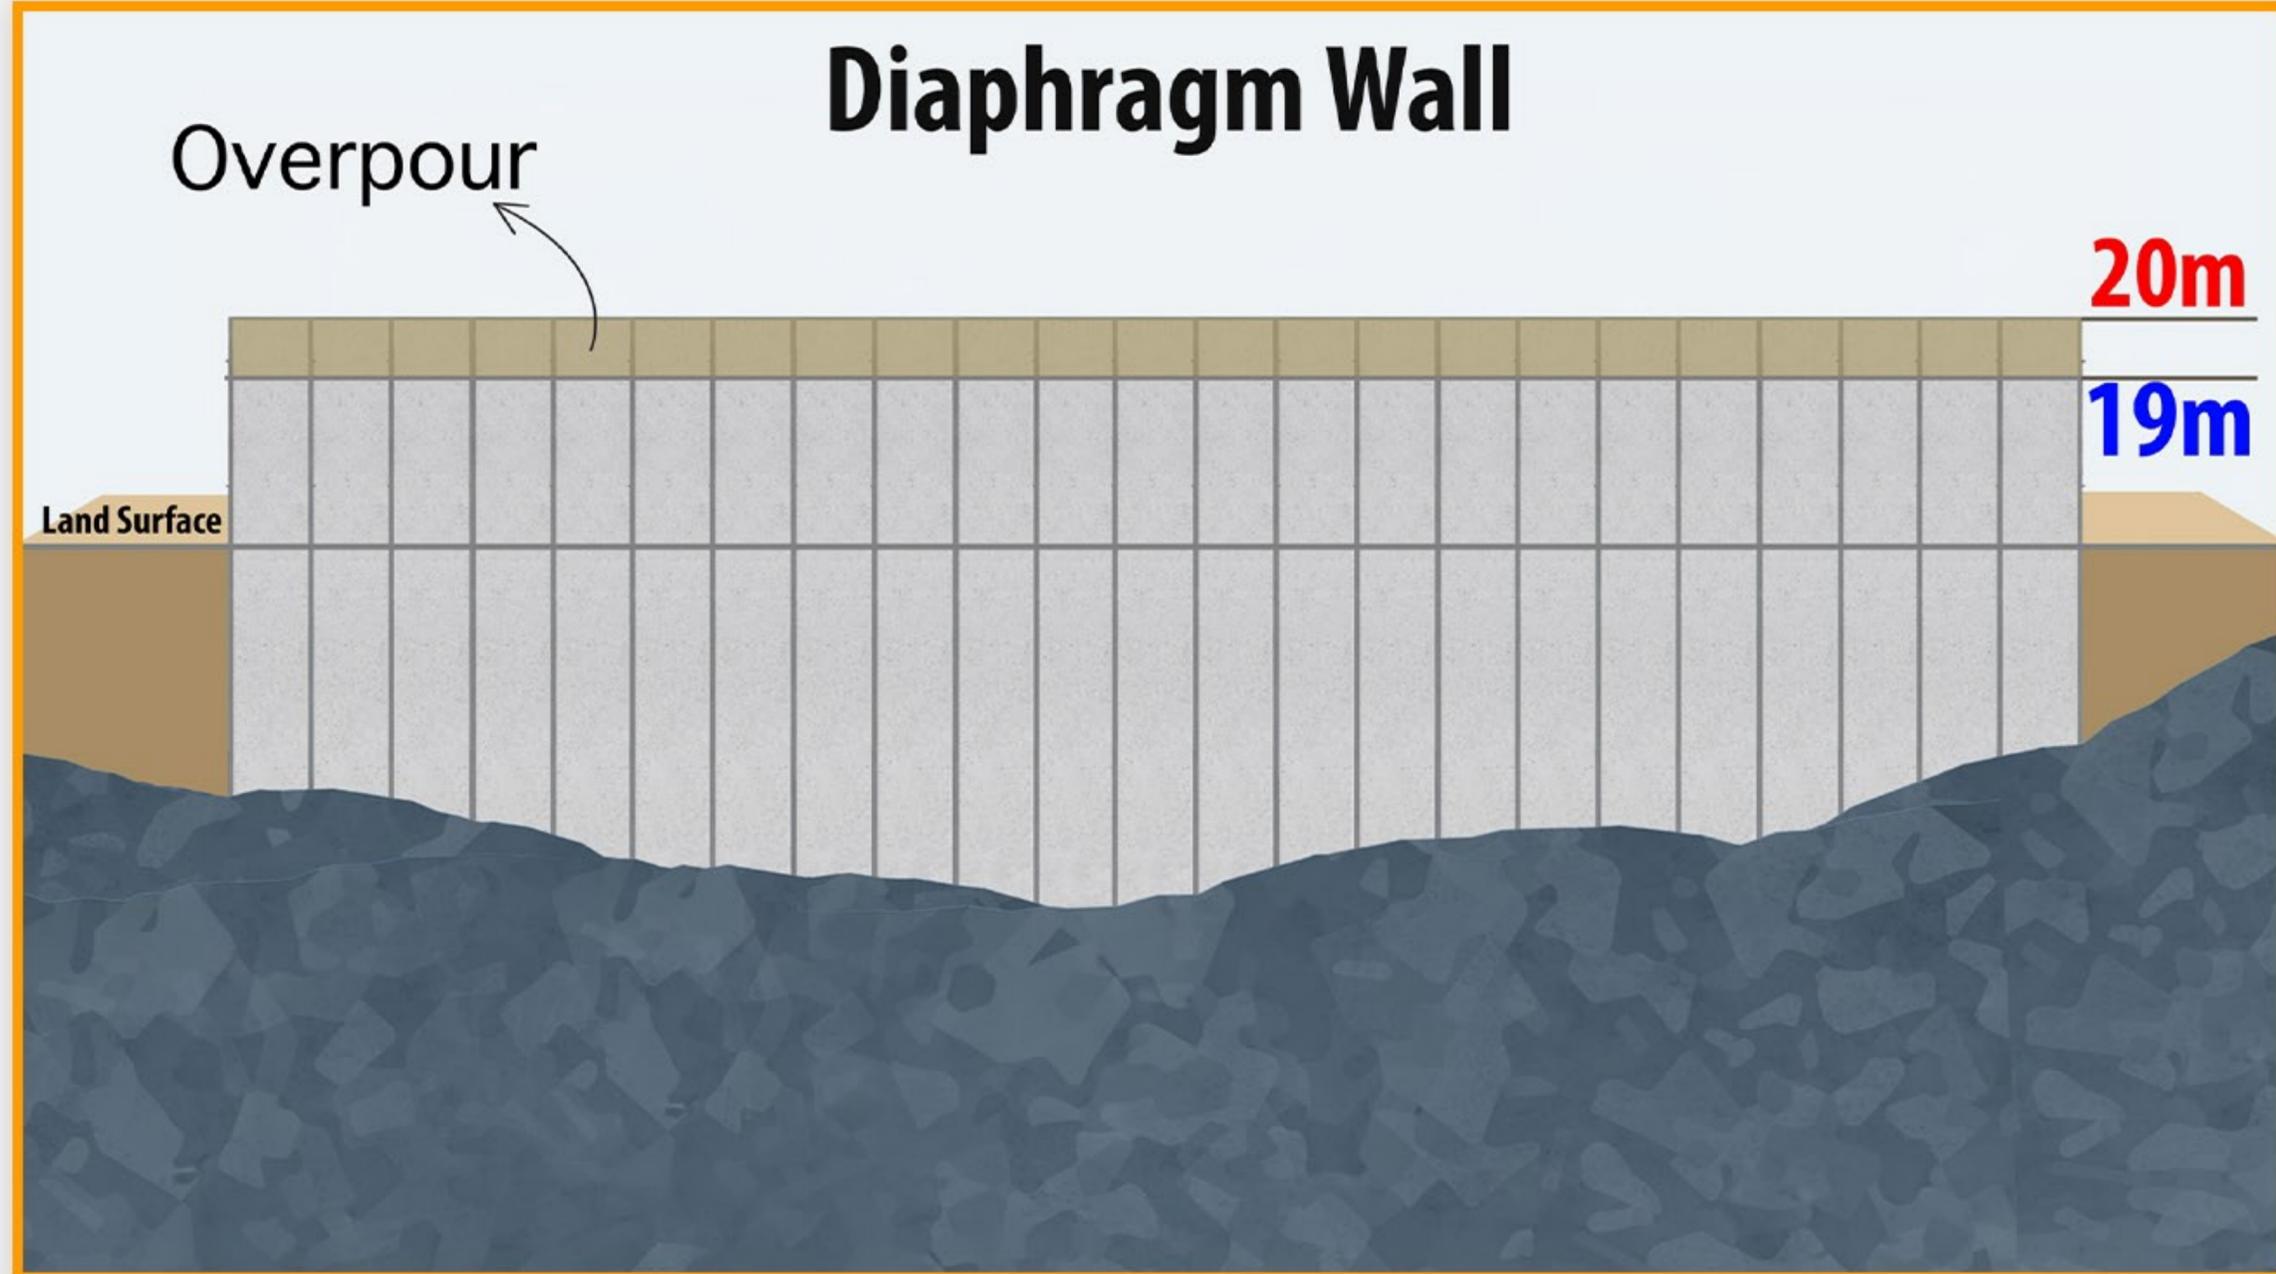
1(A). నాసిరకం కాంక్రీట్

15 నుంచి 85 మీటర్ల లోతు గోడ ప్లాస్టిక్ కాంక్రీట్తో కడతారు

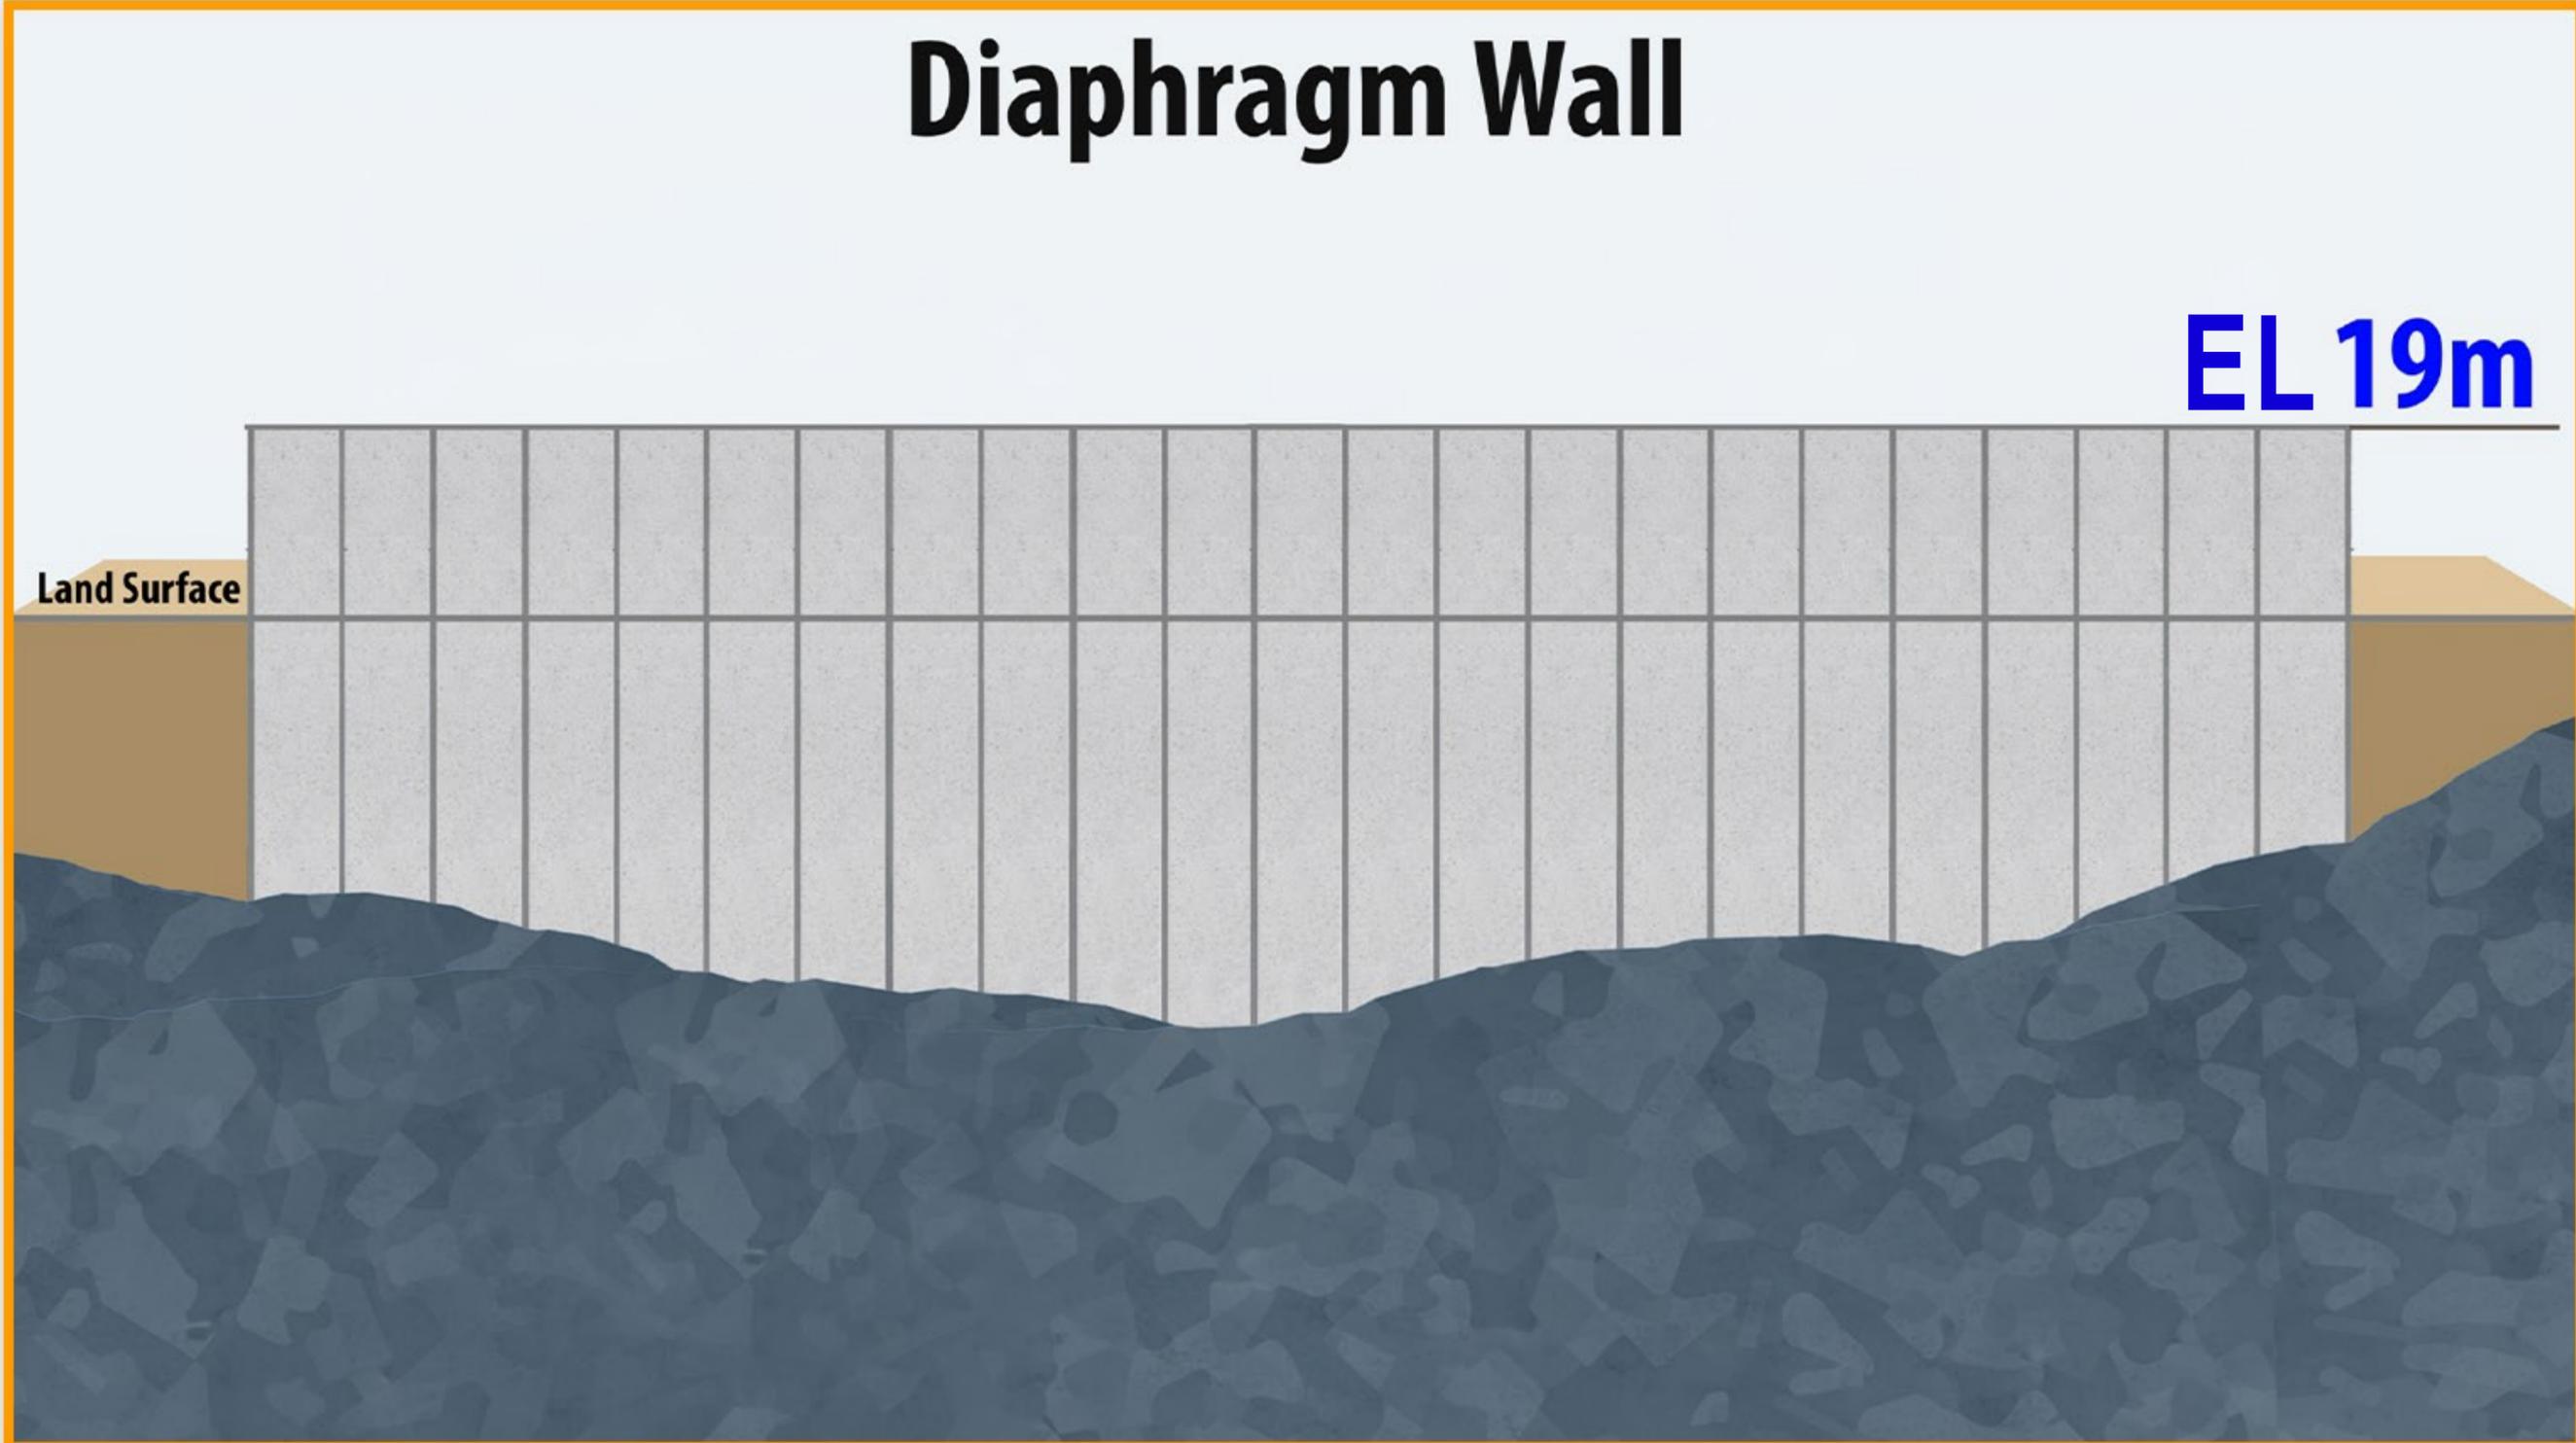
1(c). ನಾಸಿರಕಂ ಕಾಂಕ್ರೀಟ್

Diaphragm Wall

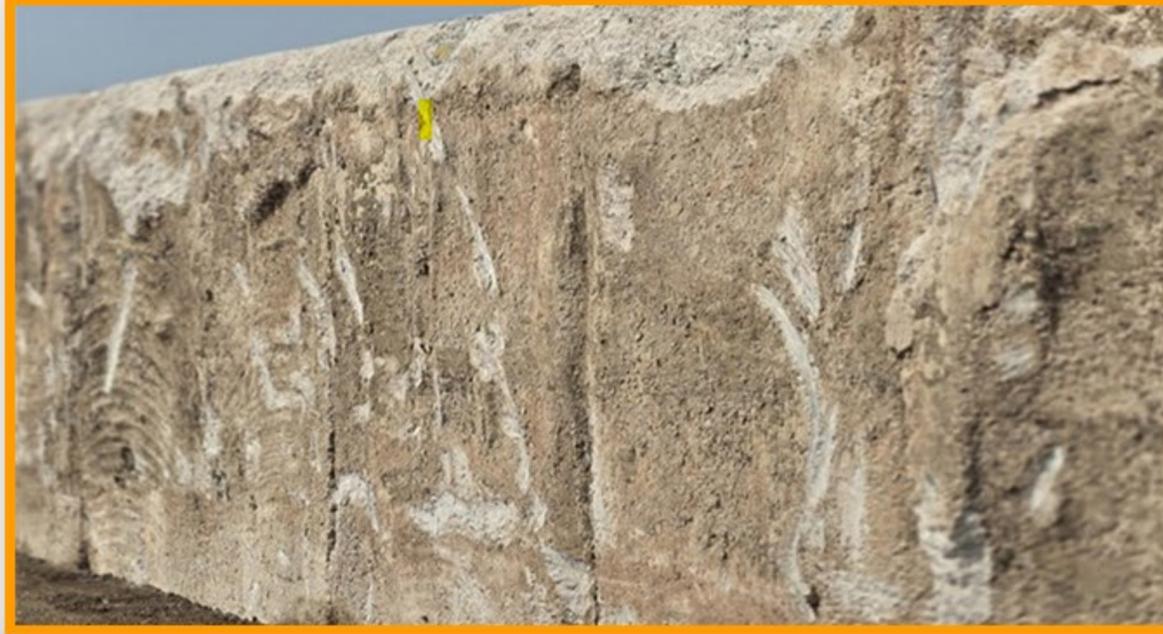
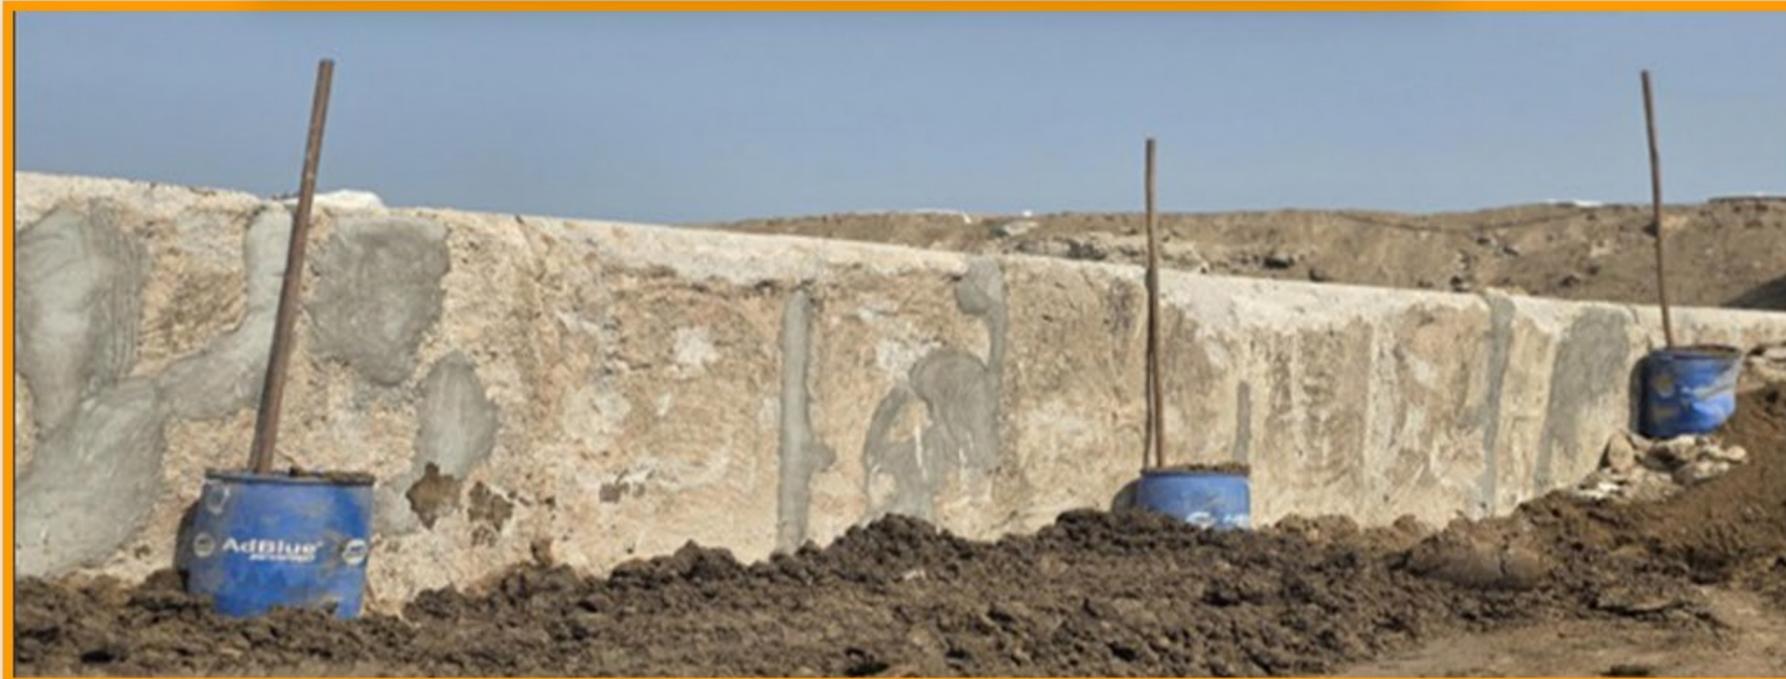
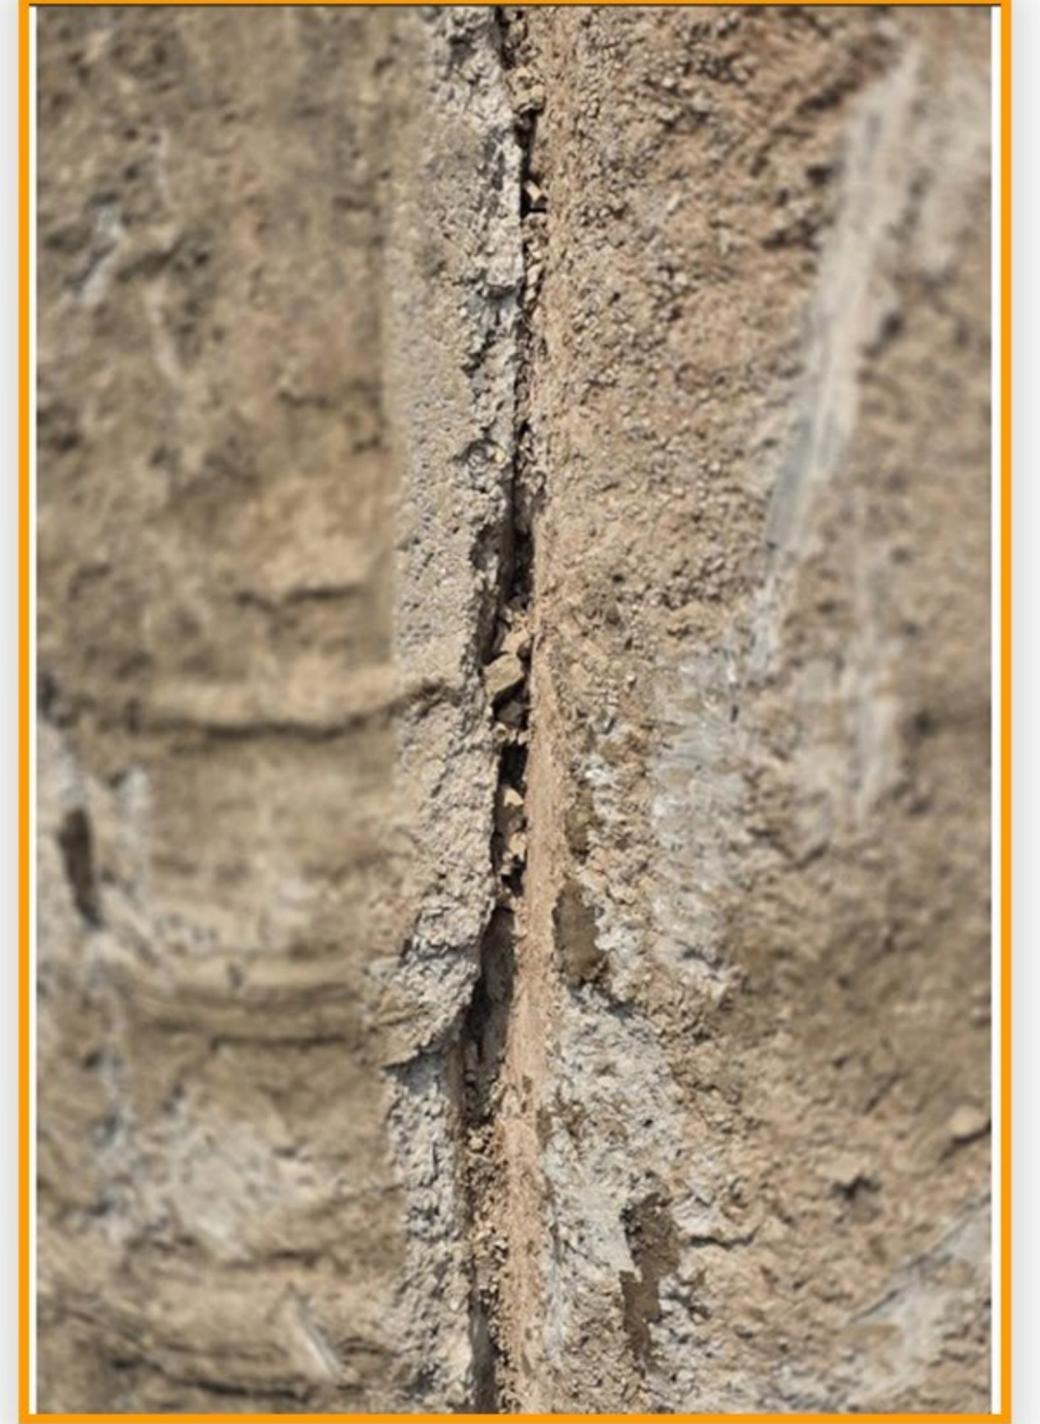
1(E). నాసిరకం కాంక్రీట్

కప్పిపుచ్చే ప్రయత్నం

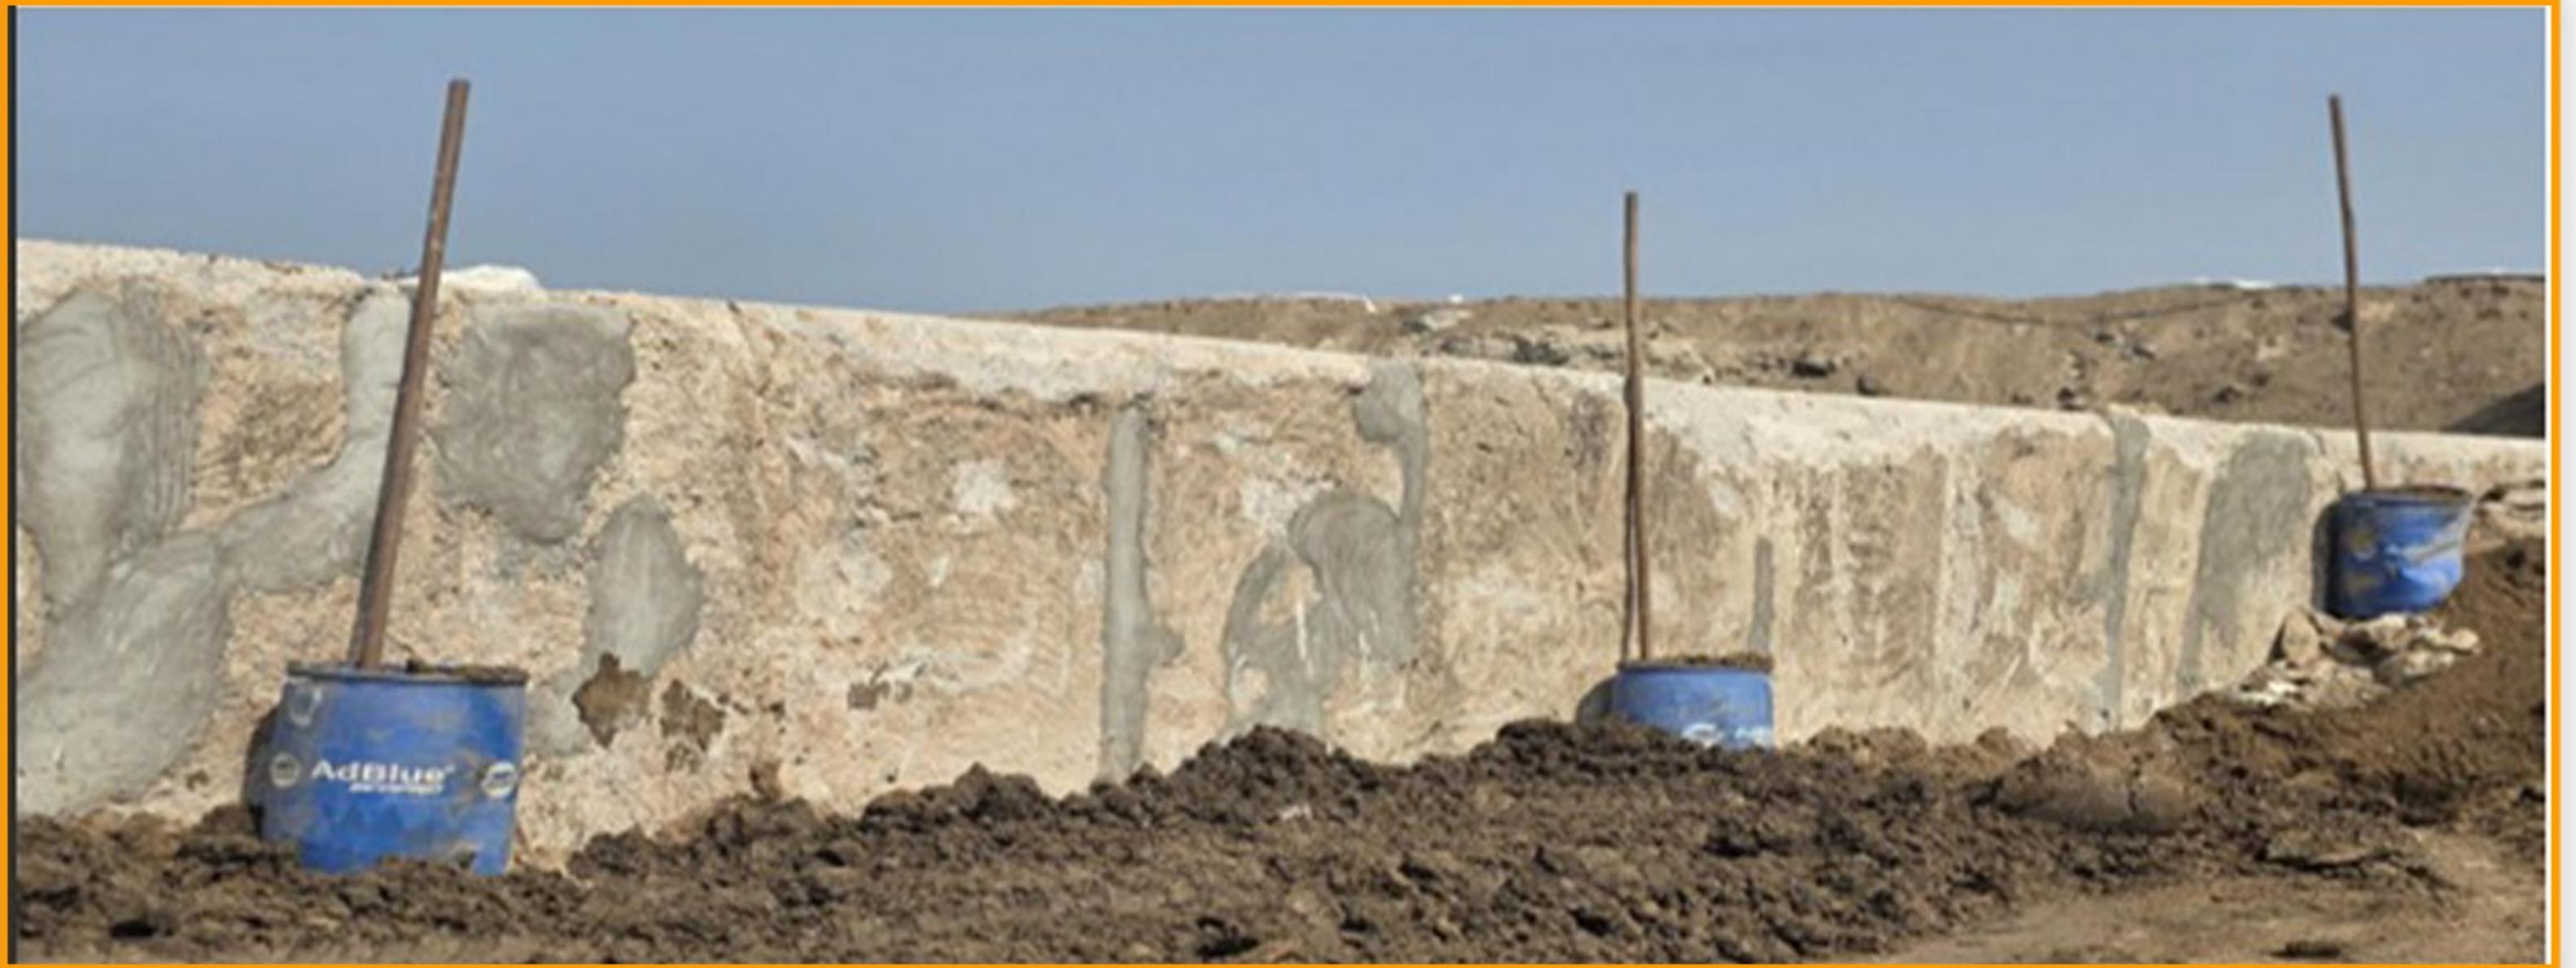
1(F). నాసిరకం కాంక్రీట్

కప్పిపుచ్చే ప్రయత్నం

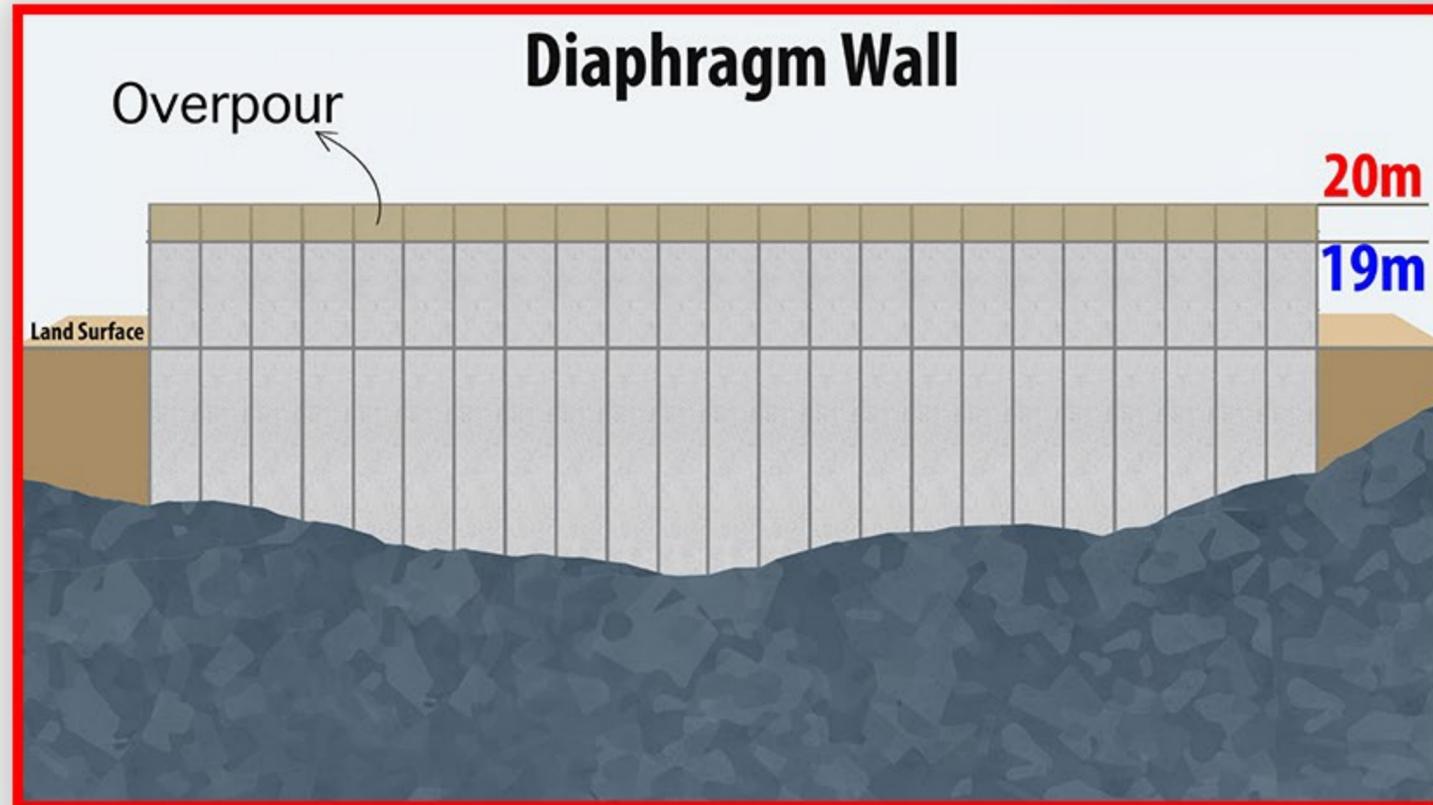
2(A). డయాఫ్రామ్ వాల్ ఎత్తు

PoE 5 : వ్యర్థాలు తేలటానికి అవసరానికి మించి పోయాల్సిన ఎత్తుకు కాంక్రీట్ పోయ్యలేదు

documented that uncertainty regarding the top elevation of the D-wall is due to poor quality plastic concrete above that level. Considering Table 3, the PoE feels that plastic concrete should have been

overpour as needed to ensure the quality of the concrete below EL. 19.0 m, as discussed and accepted by Bauer. It is disappointing to be informed at this time that the quality is unsatisfactory. At minimum, the PoE feels that the Project needs to inspect and document (in a report) the quality of the upper D-wall. This report should include photographs showing the exposed top-of-D-wall (i.e. from EL. 15.5 m

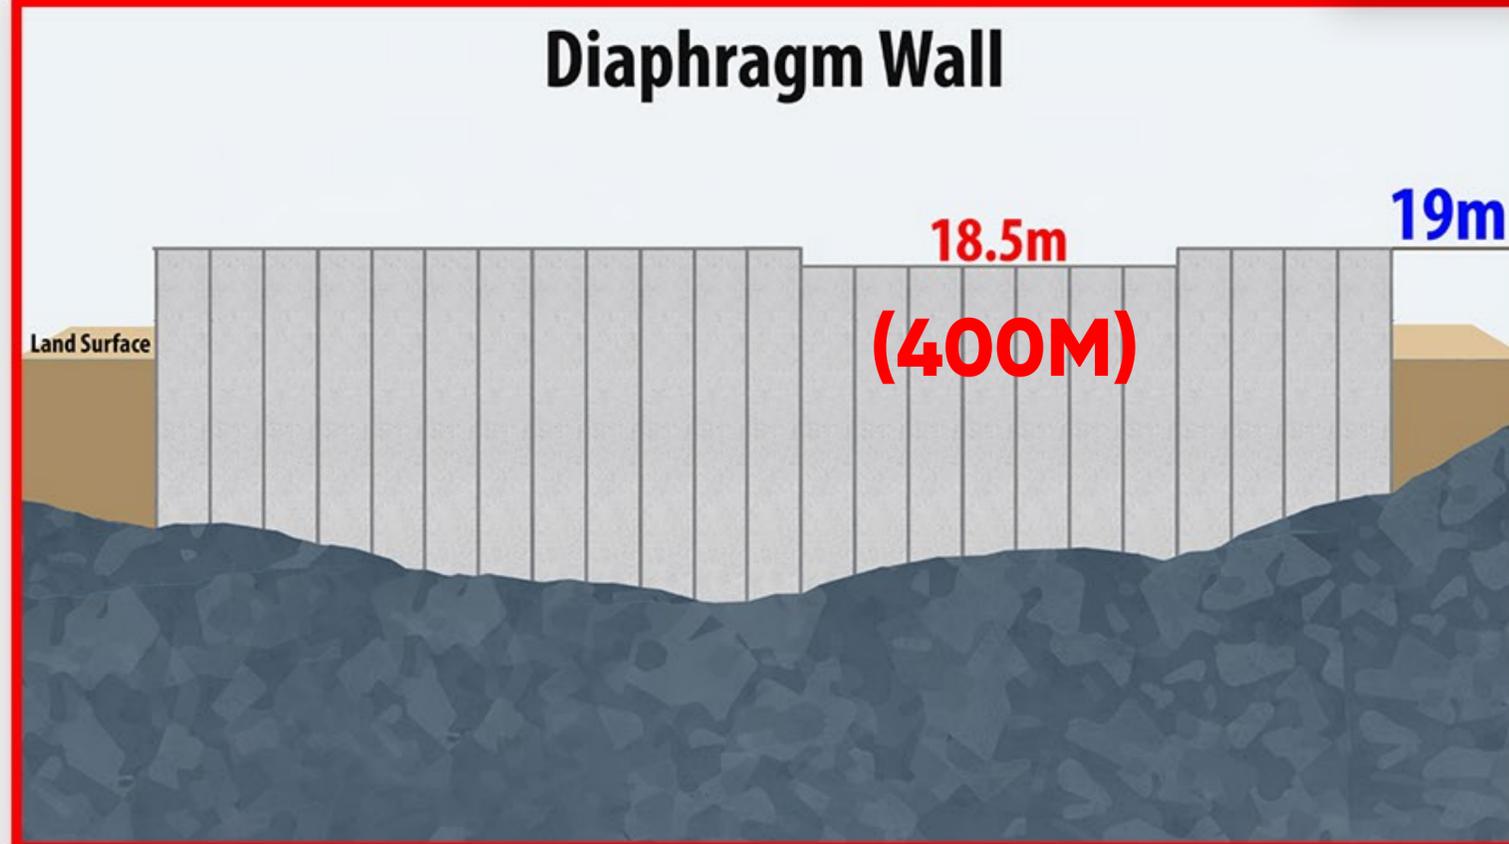
2(C). డయాఫ్రామ్ వాల్ ఎత్తు

PoE 5 : నాణ్యత లేక 19 మీటర్ల ఎత్తు గోడను 18.5 మీటర్ల ఎత్తుకి కుదించారు

overpour as needed to ensure the quality of the concrete below EL. 19.0 m, as discussed and accepted by Bauer. It is disappointing to be informed at this time that the quality is unsatisfactory. At minimum, the PoE feels that the Project needs to inspect and document (in a report) the quality of the upper D-wall. This report should include photographs showing the exposed top-of-D-wall (i.e. from EL. 15.5 m to top) with chainage markers. The report should also include physical tests, including coring and Schmidt hammer tests and cross-wall sonic logging, where possible. That report will provide a basis for the new top elevation. As discussed below, cutting the wall down to EL. 18.5 m (or possibly EL. 18 m) poses problems, which must be addressed.

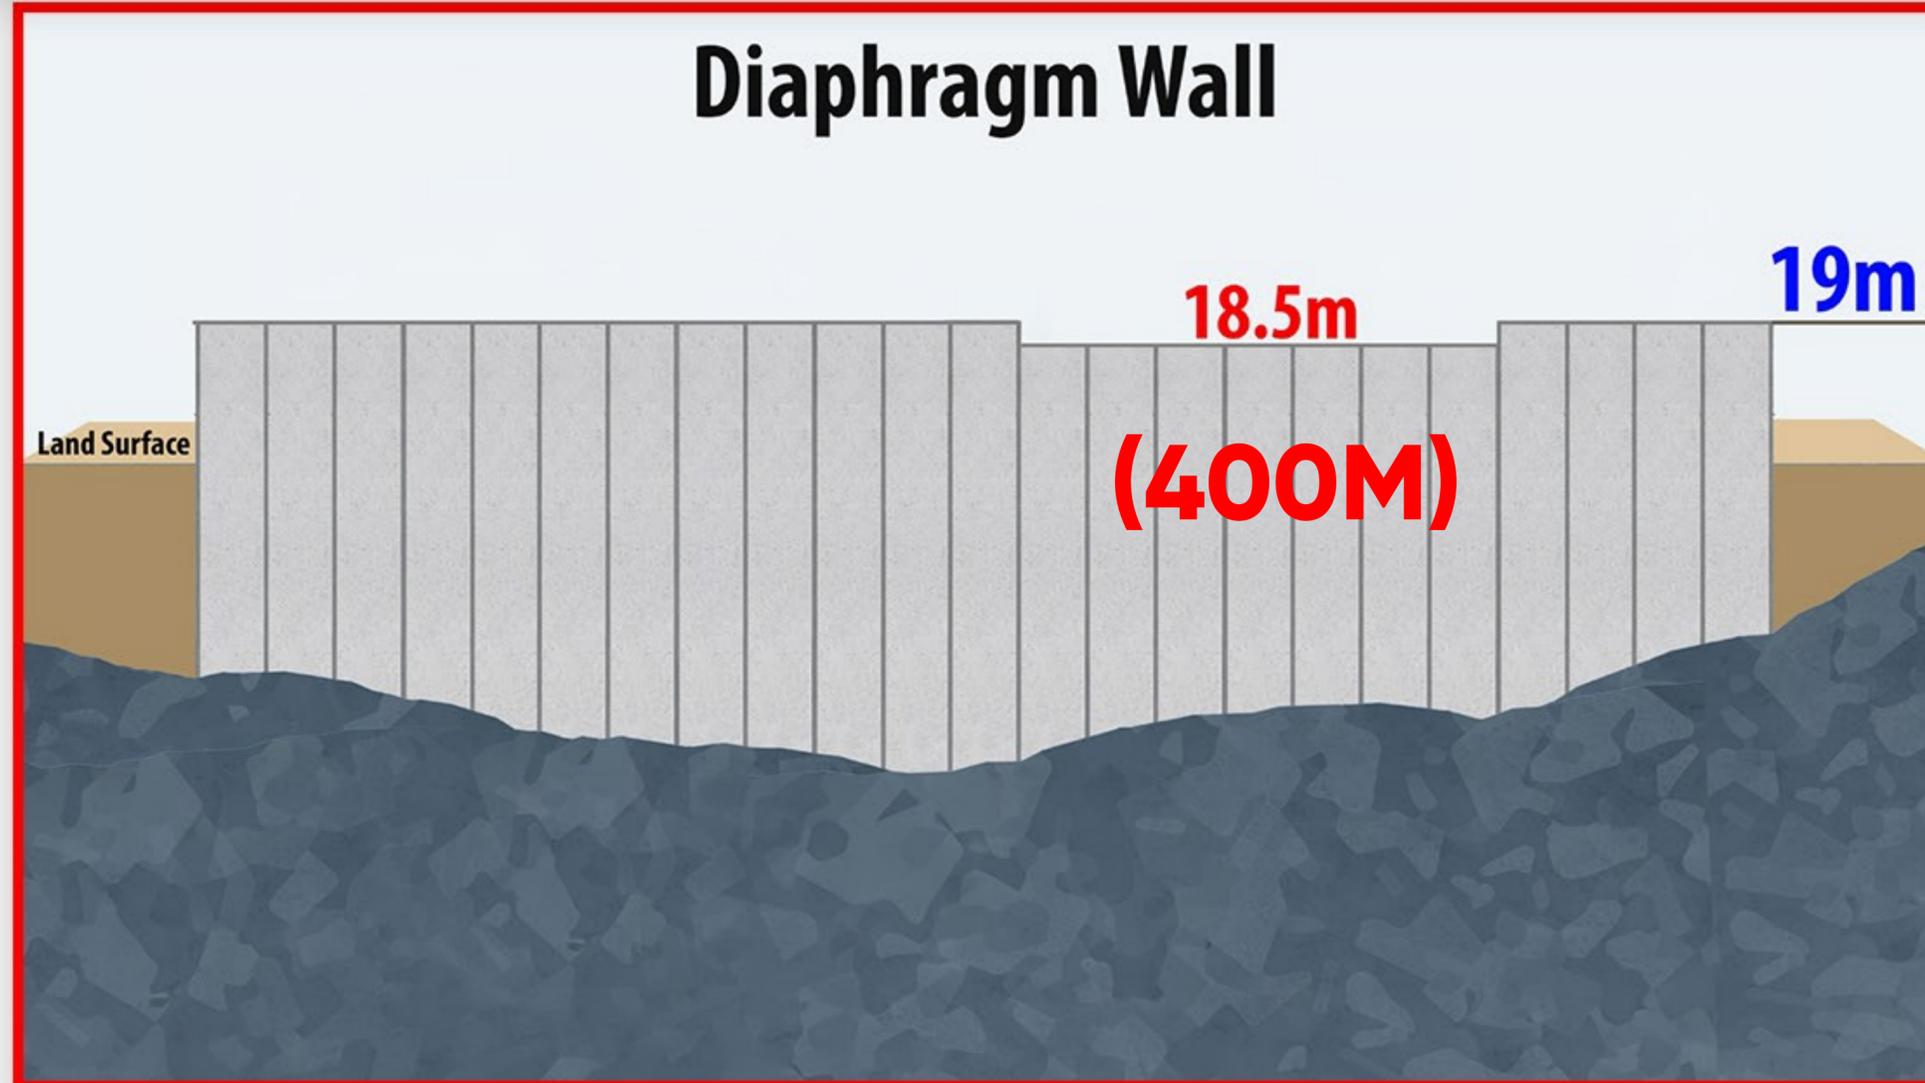
2(D). ಡಯಾಫ್ರಾಂ ವಾಲ್ ಎತ್ತು

PoE 5 : 400 ಮೀಟರು ಗೆಡ ಎತ್ತುನ ಕುರಿತು

embedment criteria for D wall adopted was presented. It was also informed that the top of D wall has already been cut down to elevation +18.5m, for about 400m in length, out of the total length of ~1400m of D wall.

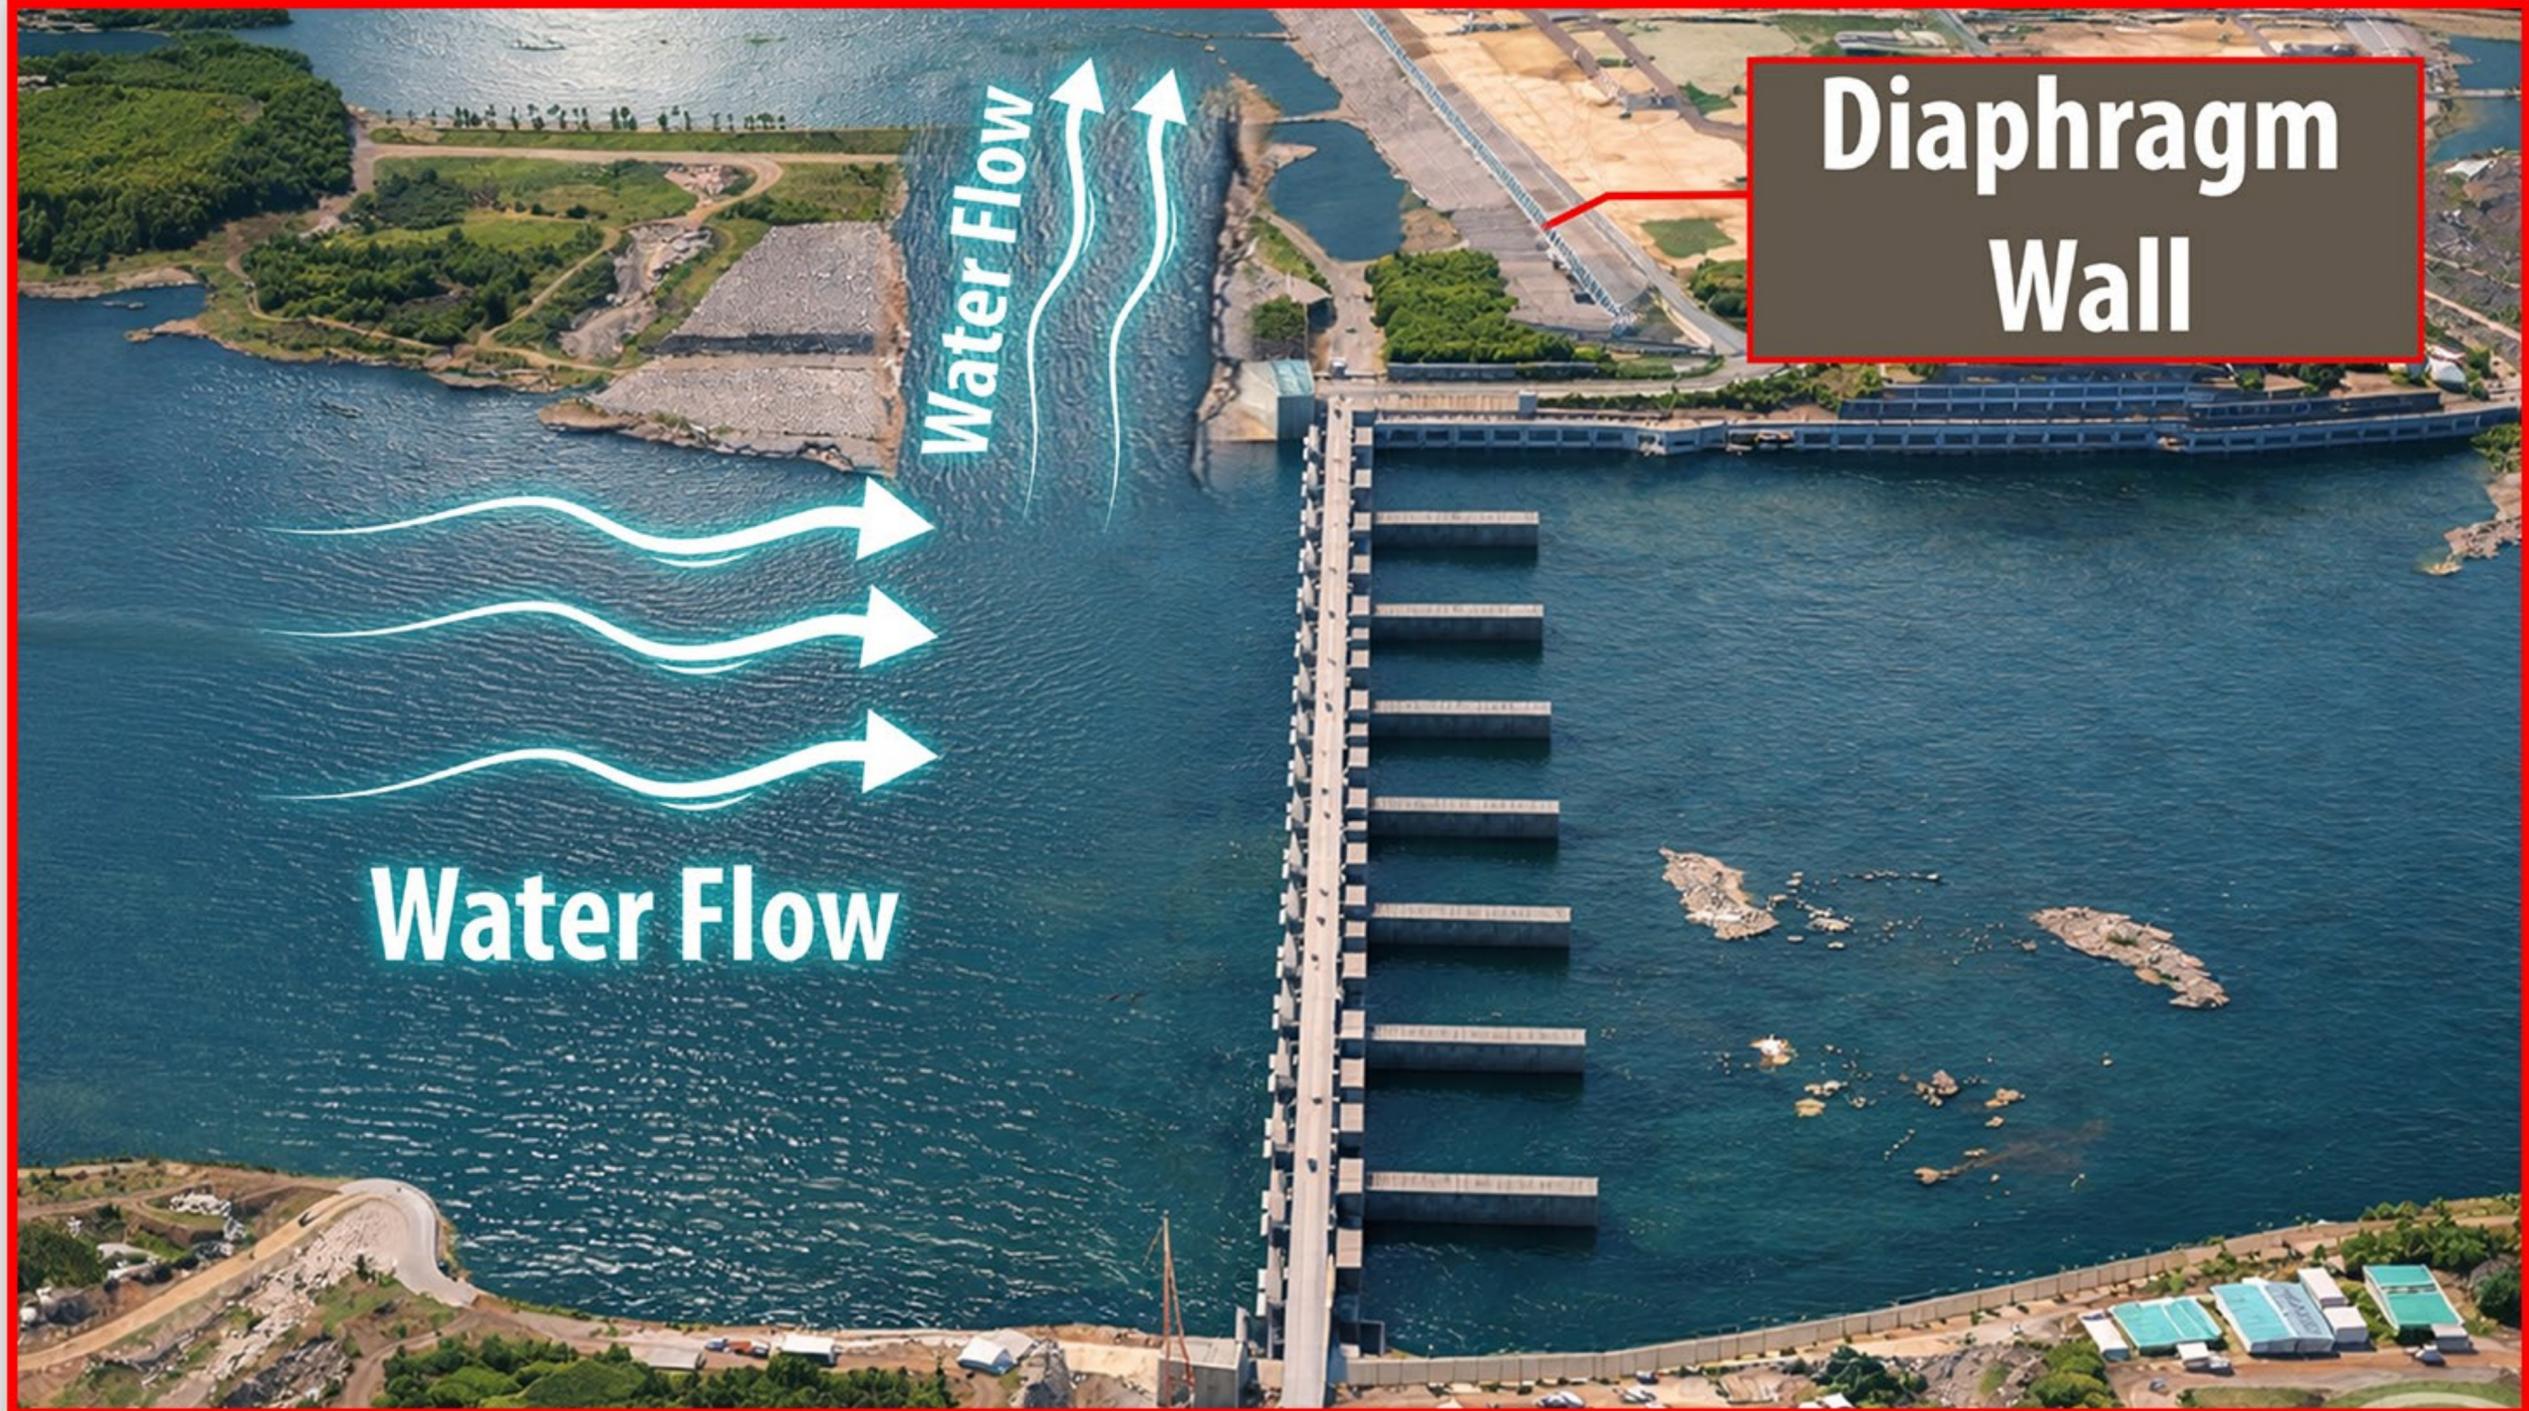
4(C). గైడ్ బండ్ నిర్మాణం

గైడ్ బండ్ వరద వచ్చి కొట్టుకుపోతే,డయాఫ్రామ్ వాల్ మళ్లీ ధ్వంసం అవుతుంది
