పోలవరం నిర్మాణంలో నాణ్యతా లోపాలు

కప్పిపుచ్చే ప్రయత్నాలు

02-03-2026

మీడియా సమావేశం, విజయవాడ

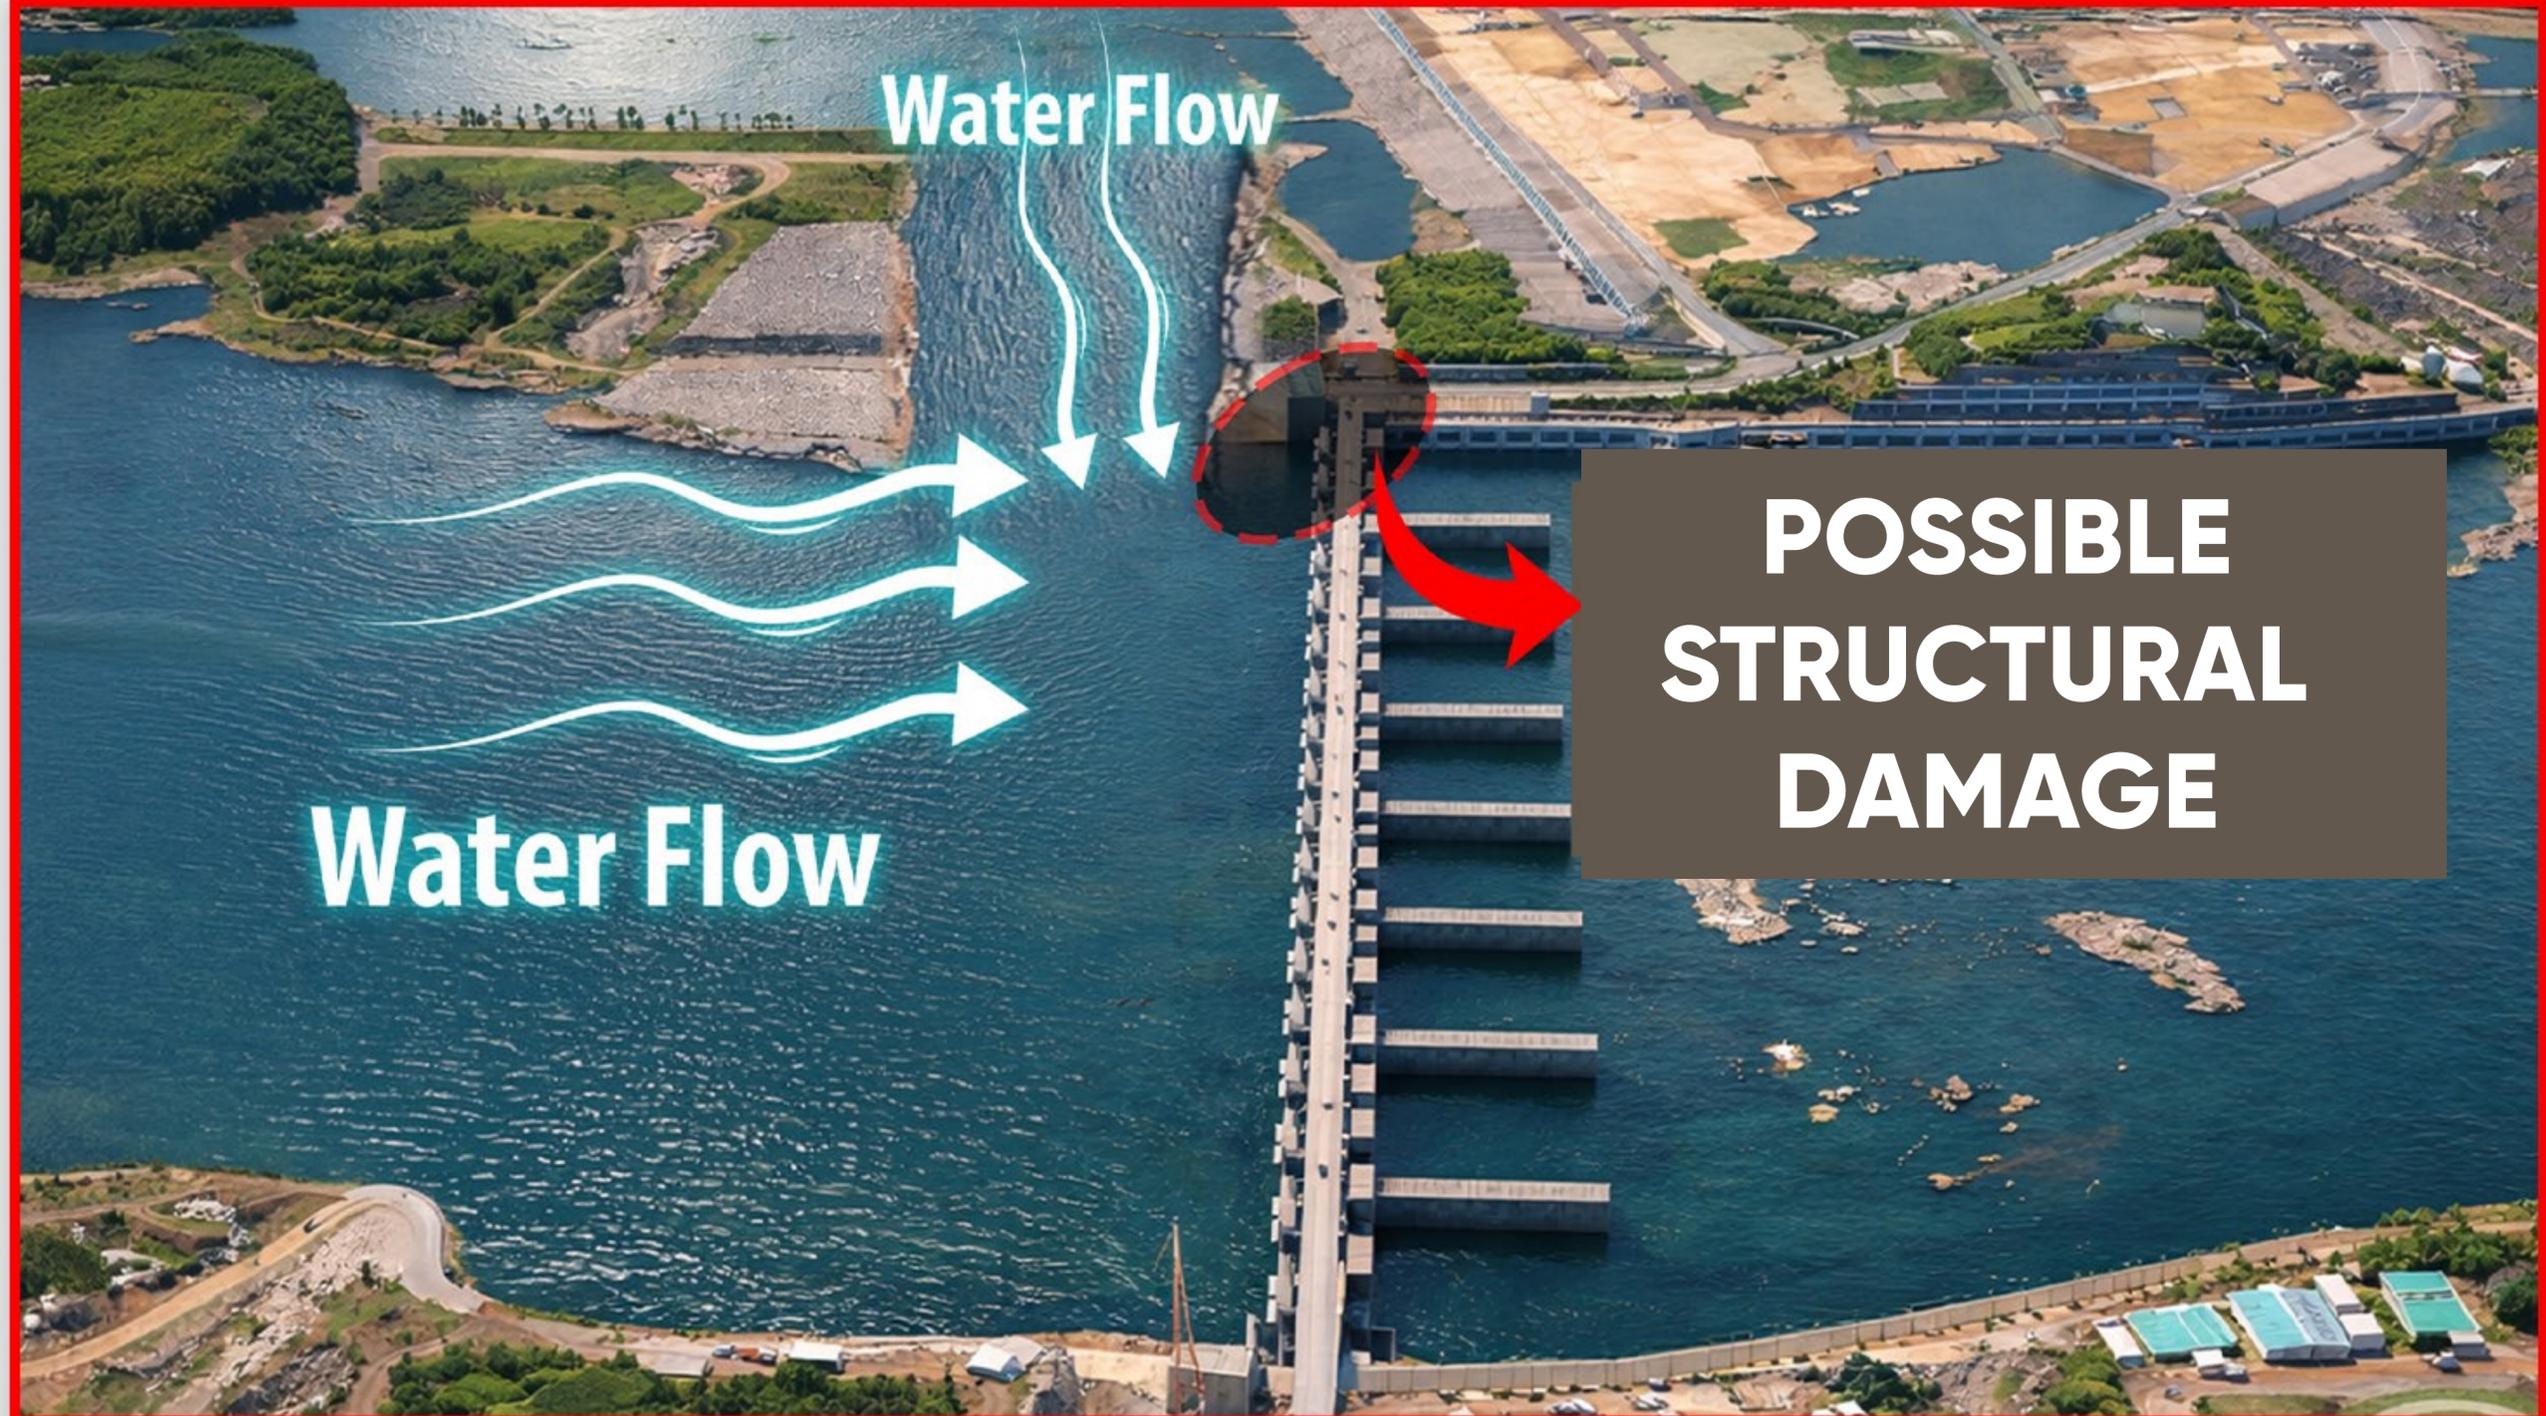
4(D). గైడ్ బండ్ నిర్మాణం

స్పిల్ వే కి కూడా ప్రమాదం
