పోలవరం నిర్మాణంలో నాణ్యతా లోపాలు

కప్పిపుచ్చే ప్రయత్నాలు

02-03-2026

మీడియా సమావేశం, విజయవాడ

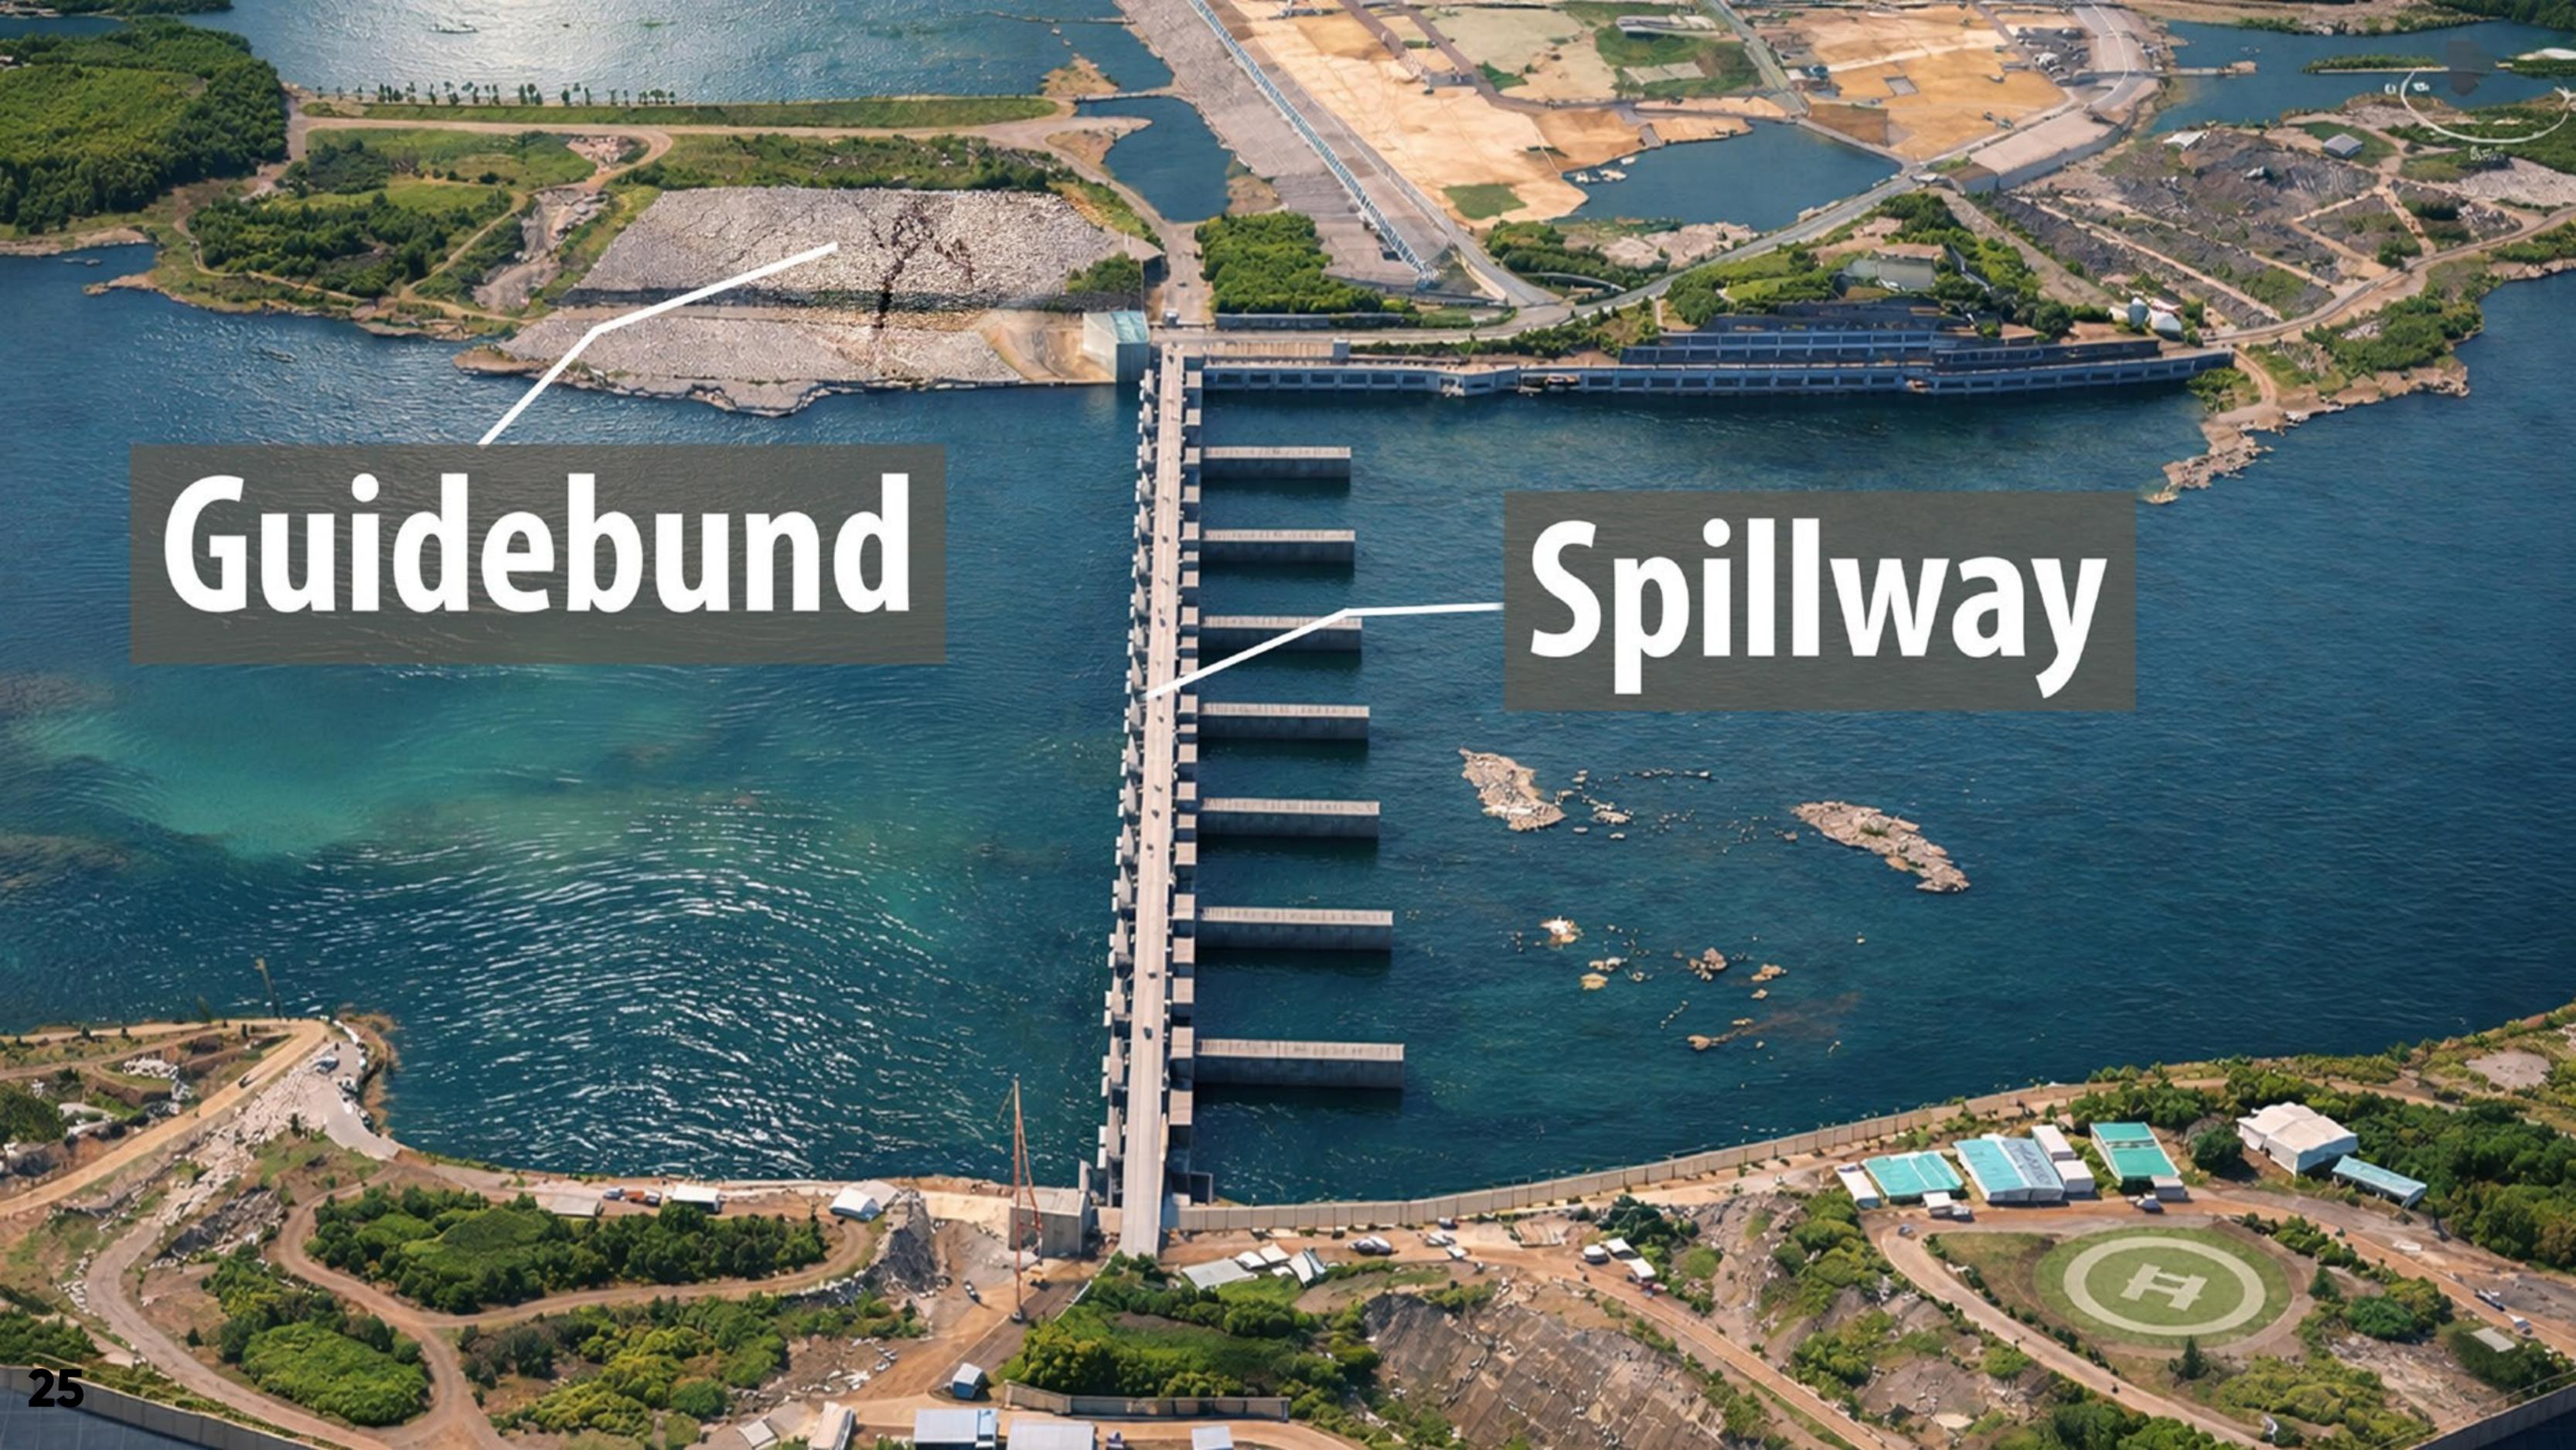
4. గుడ్ బండ్ నిర్వహణ

Guidebund

The Guide Bund remediation will require the design and construction of a new D-Wall, the removal of the failed, old, D-Wall together with the possible re-alignment of the wall. The PoE is recommending the following considerations:
